## **National Register of Historic Places – Sample Nomination Form Helton-Mayo Farm, Lawrence County, Indiana**

This nomination documents a southern Indiana farm that includes an early vernacular brick house, log barn, various special-use farm buildings, as well as a 1950 arched-roof dairy barn. The authors drew on census data, local histories, and evidence offered in the buildings themselves to explain how the property meets the National Register Criteria in the areas of agriculture, settlement and architecture. If you're having trouble classifying the vernacular architecture of your farm, the Indiana Division of Historic Preservation and Archaeology can help. The map provides the reader with a sense of the organization of the farm and helps define contributing (historic) from non-contributing (non-historic) buildings. Many internet services or county offices provide aerial mapping or other graphic mapping systems that can be used to prepare maps for properties with numerous support buildings.

**National Register of Historic Places  
Registration Form**

historic name Helton-Mayo Farm

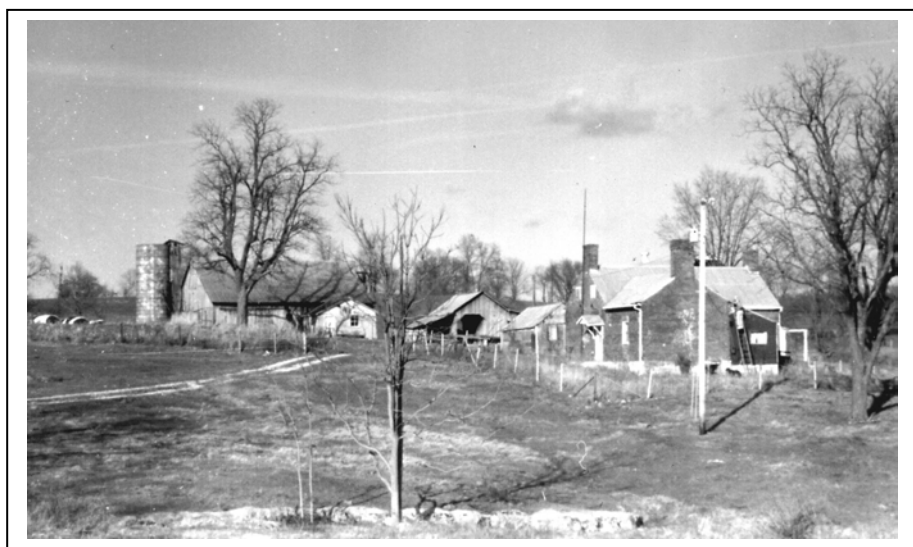
*This photo of the Helton-Mayo Farm captures the overall layout of the farmstead. Don't forget to give your application the big picture as well as the details!*

The Helton-Mayo Farm occupies a site just west of S.R. 58 in northeast Shawswick Township about two miles northeast of Bedford in Lawrence County, Indiana. Terrain is typical gently rolling farmland characteristic of southern Indiana. The 13 acre farm includes seven contributing resources: the house, Midwest Three-Portal barn which encloses an early 1800s log barn, a round roofed barn built in 1950, a stone wellhouse, a buggy shed, a garage; all counted as buildings, and a drive through corn crib; counted as a contributing structure. There is one non-contributing building: a privy. The farm buildings are clustered in a grid-like fashion with the house being the southernmost of the group, yet it faces north toward the farm buildings, which is unusual in a Hoosier farmstead. A now missing path of road may explain the unusual orientation, as may the need for north light for the interior of the home.

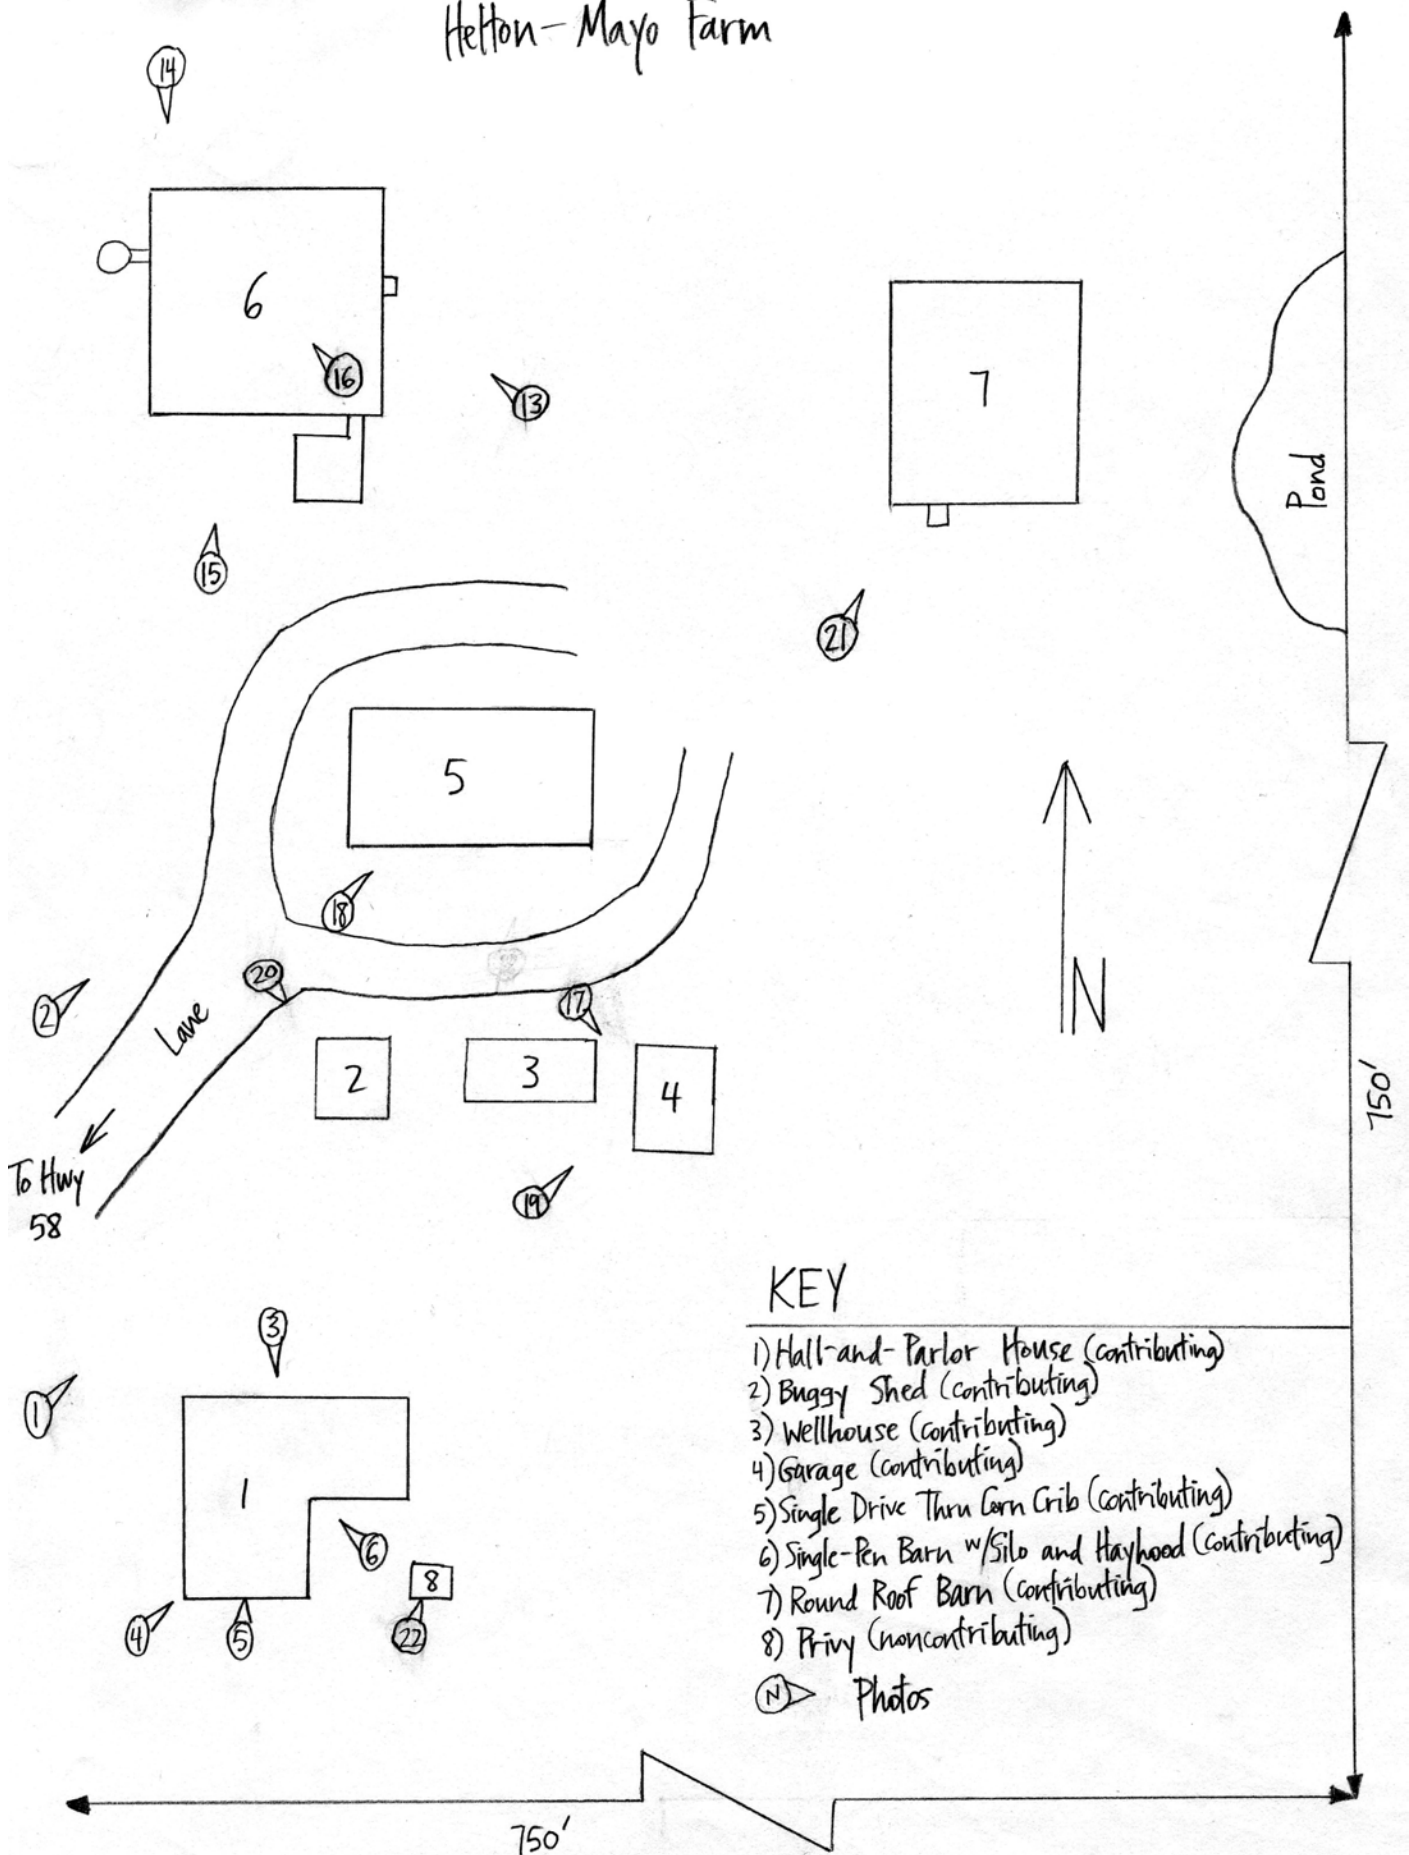
# Helton-Mayo Farm

A square parcel roughly 750 feet by 750 feet located in the northwest quarter of Section 7, Township 5 North, Range 1 East in Lawrence County, Indiana, the southwest corner of which is located at the western post of a gate on the entrance lane leading to the house and barn lot. Boundary is further defined by the sketch map included with the nomination and by the UTM points given in section 10.
